THIRD-PARTY LONG-TERM TESTING: CUI & THERMAL RESULTS

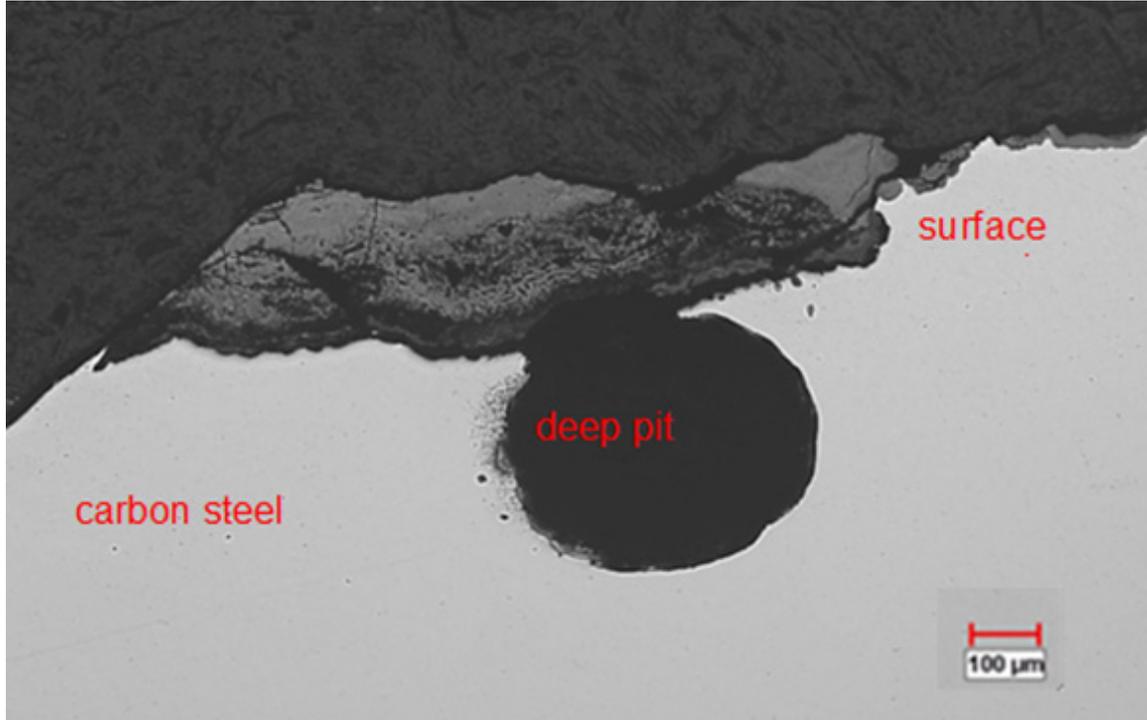
Figure 1: Optical cross-section of a carbon steel surface under the aerogel blanket insulation after high-temperature cycling conditions, showing deep, localized pitting. Deep, localized pitting is more concerning than uniform shallow pits.

- At constant low temperatures (45°F conditions), InsulThin HT and the silica aerogel blanket have similar corrosion rates and depths.
- At high-temperature cycling conditions (between ambient and 600°F), InsulThin HT has lower corrosion rates and depths compared to the silica aerogel blanket.
- Deep, localized pitting is more significant in high-temperature conditions with the silica aerogel blanket than it is with InsulThin HT (Figure 1).

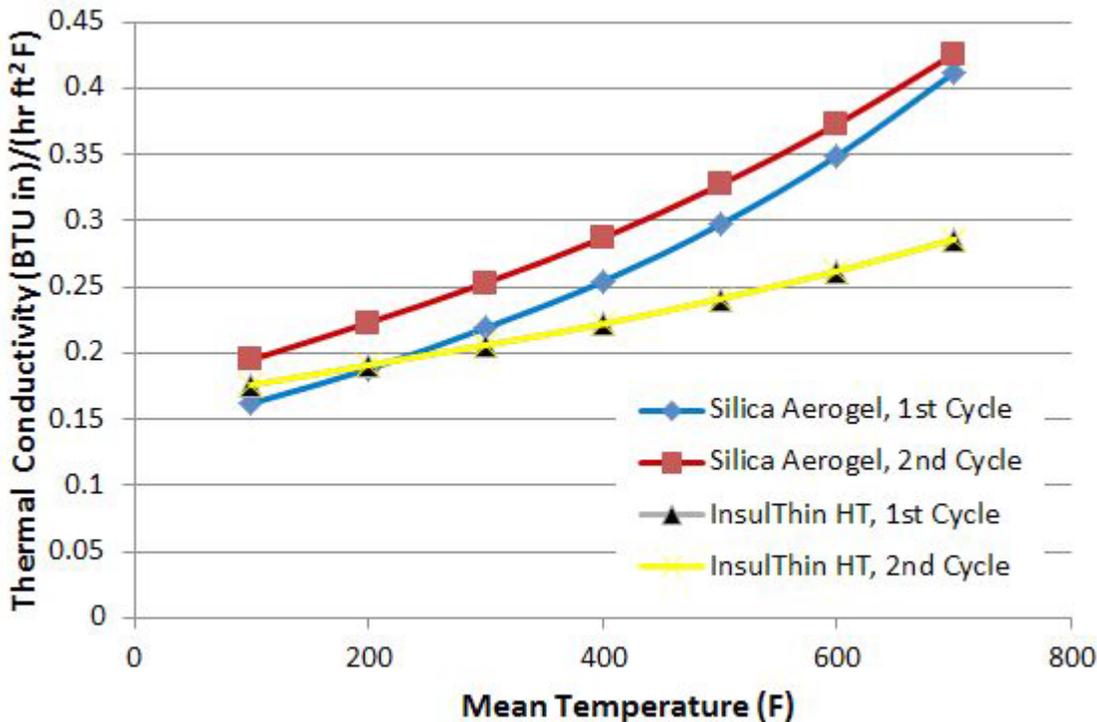
Figure 2: Thermal conductivity values tested via ASTM C335 before (1st cycle) and after (2nd cycle) thermal shift. Note the thermal conductivity values for InsulThin HT do not vary between the 1st and 2nd cycles.

For the two insulation assemblies that were cycled to 600°F, the surface temperatures were recorded when the assemblies were dry (not submerged in water) at different times during the test (Table 2). The data show significant differences in thermal performance between the two blankets over time. Temperatures based on NAIMA 3E Plus® software for both insulations before and after thermal shift (change in thermal conductivity after exposure to high process temperatures) also show differences in the expected thermal performance. Thermal conductivities based on ASTM C335 (pipe geometry) were used for the modeling calculations (Figure 2).
